May 4, 2018

I am writing in response to the Marmol Radziner's second modified proposal for historic paint palette restoration for the Town & Country Center which will be reviewed at the Historic Site Preservation Board meeting on Tuesday, May 8, 2018.

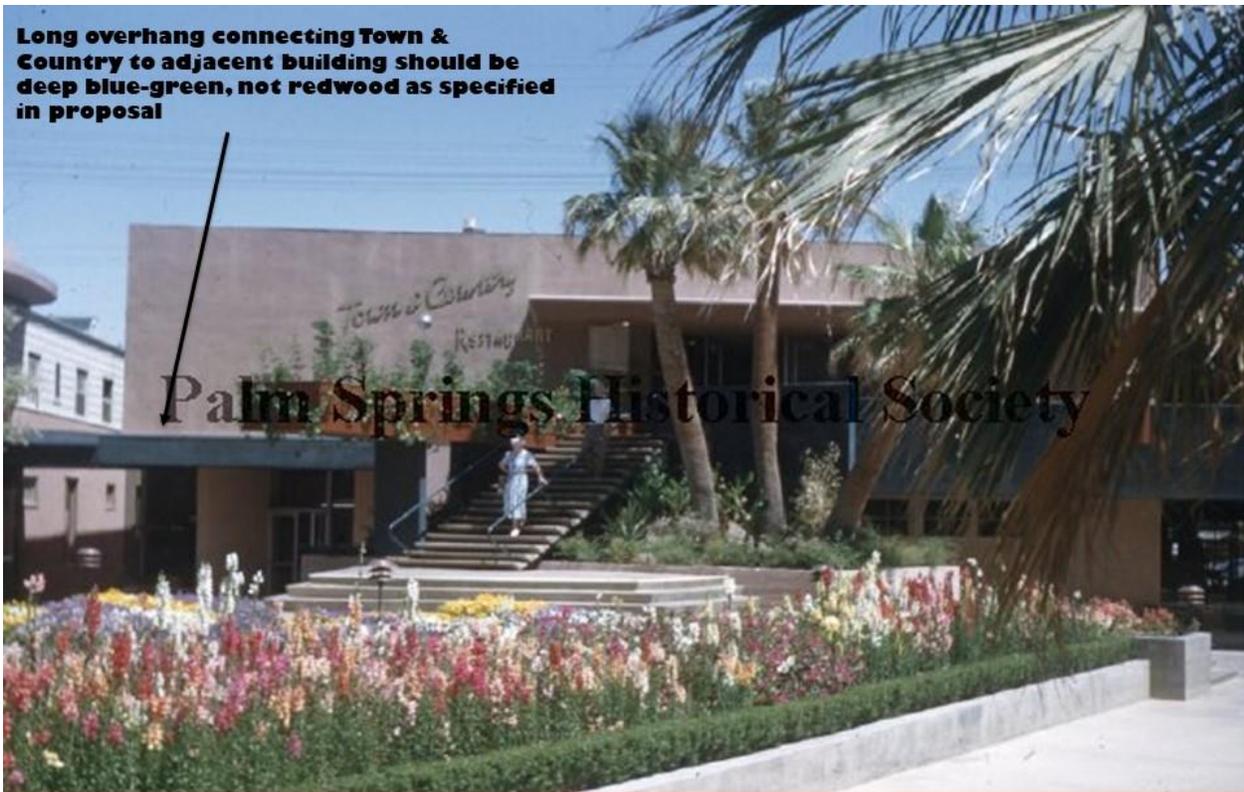
Long overhang connecting Town & Country to adjacent building should be deep blue-green, not redwood as specified in proposal

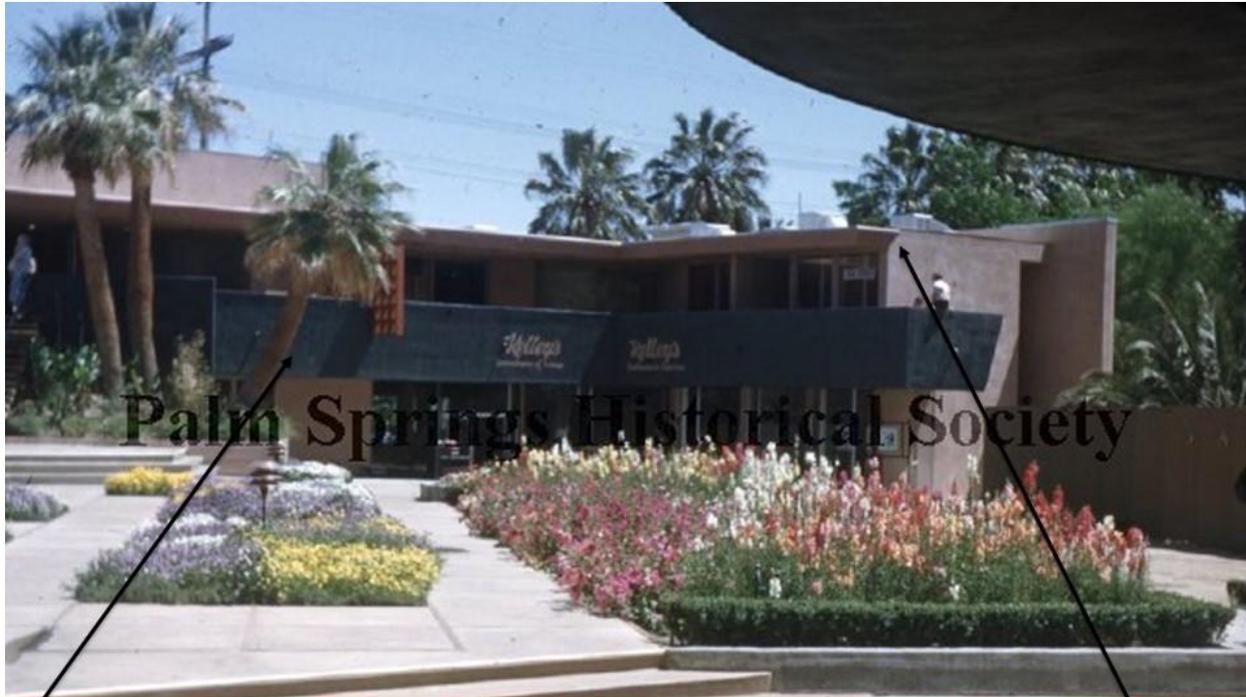
Fronts of balconies should be painted deep blue-green, not redwood as proposed.

Also, fascia appears to be painted the same pinkish-tan as the main body of the building. The fascia is canted downward, casting it in shadow, making it appear to be painted a darker color. But that may be deceiving. Paint analysis should be done in this location to verify. But it doesn't appear to be redwood or painted a redwood color, which is proposed.

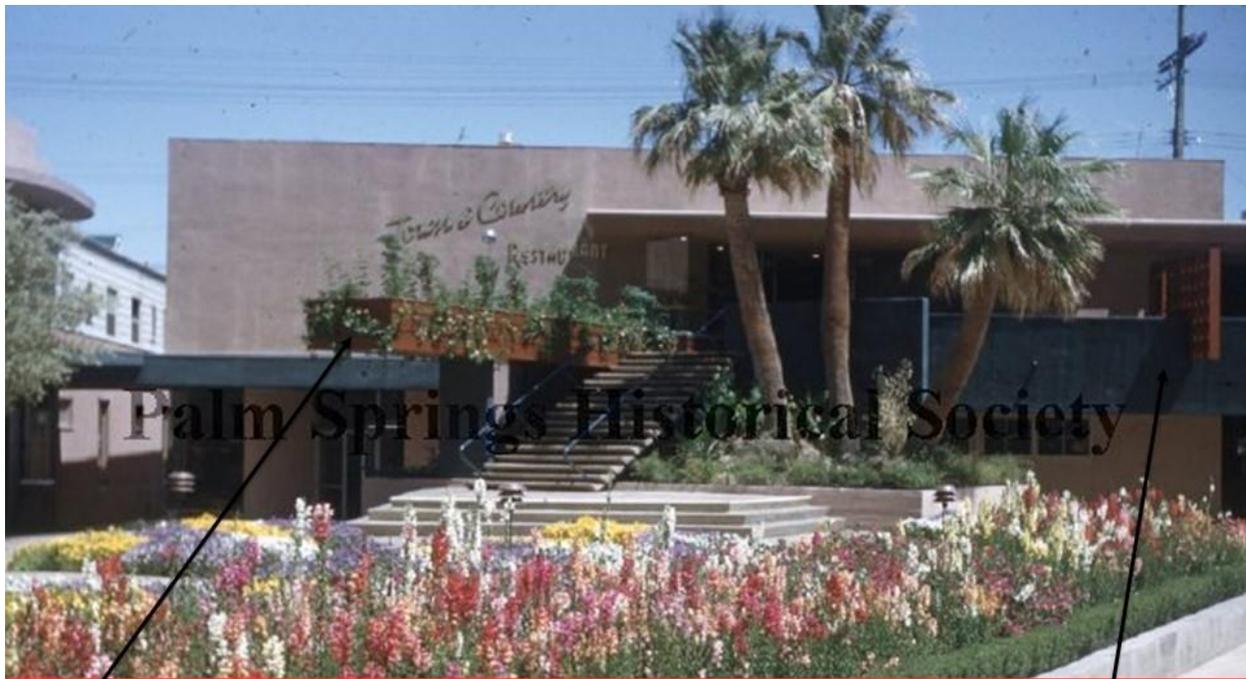
Horizontal redwood parapet planter box appears to be natural stained redwood. The Late Moderne box grid, extending beyond the roof plane and piercing the balcony wall, also appears to be natural stained redwood. A. Quincy Jones was using natural redwood, box grids and long horizontal parapets frequently in this period, in buildings such as the Nordlinger Residence. These redwood features are meant to be decorative punctuation marks in the composition, so their materials are distinctly different than the painted stucco of the overall composition.

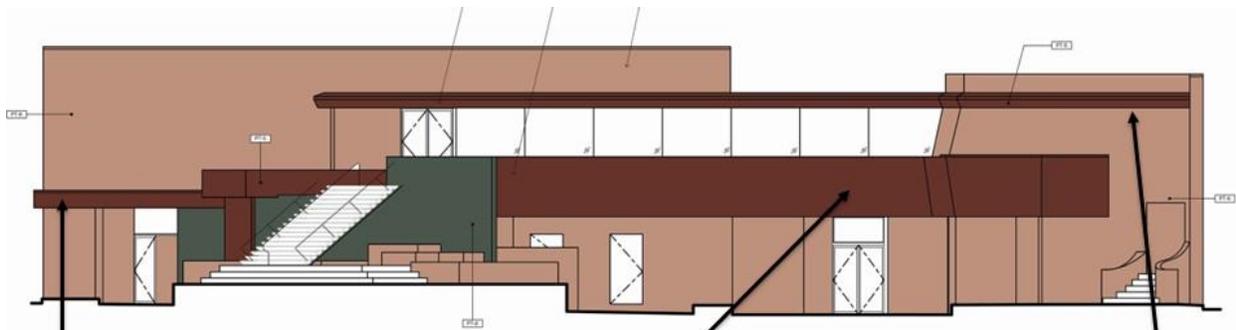
These balcony fronts should be painted deep blue-green, not redwood or redwood colored paint as proposed here.

The fascia does not appear to be redwood or a redwood colored paint, as proposed here. Further analysis should be done, based on Kodachrome photograph provided.

This overhang, connecting the Town & Country Restaurant building to the adjacent structure should be painted deep blue-green, not this redwood color as proposed.
